Aviation Investigation Final Report

Location:	Kaupo, Hawaii	Accident Number:	ANC23FA008
Date & Time:	December 15, 2022, 21:14 Local	Registration:	N13GZ
Aircraft:	RAYTHEON AIRCRAFT COMPANY C90A	Aircraft Damage:	Substantial
Defining Event:	Inflight upset	Injuries:	3 Fatal
Flight Conducted Under:	Part 91: General aviation - Positioning

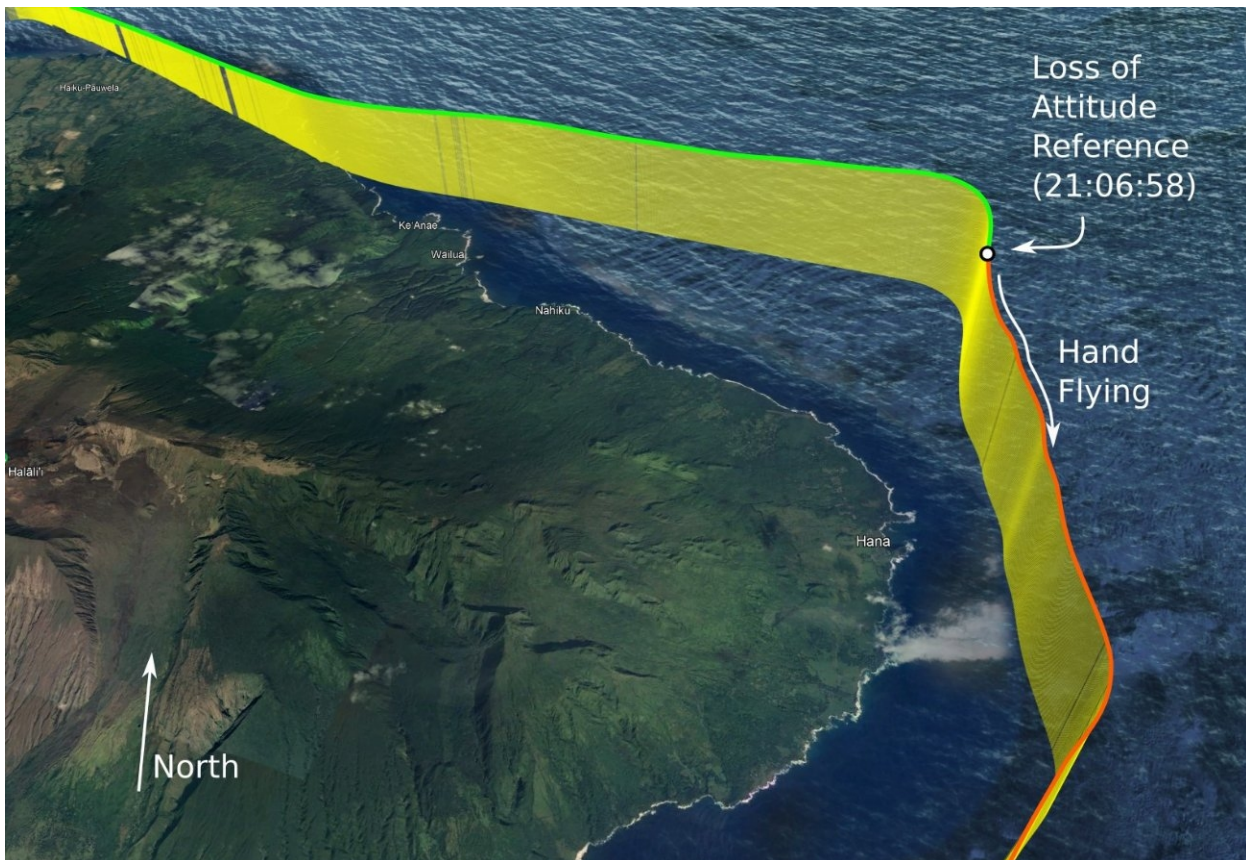
About 2106, the autopilot disconnect alert tone sounded, and the autopilot disconnect light illuminated. The pilot's Electric Attitude Director Indicator (EADI) did not display artificial horizon information for the duration of the flight, red warnings flashed several times, and then remained lit (see Figure 1). The flight nurse asked the pilot if the autopilot had disconnected, and the pilot confirmed to the flight nurse that it had.

Figure 1. Google Earth image of portion of the flight path.

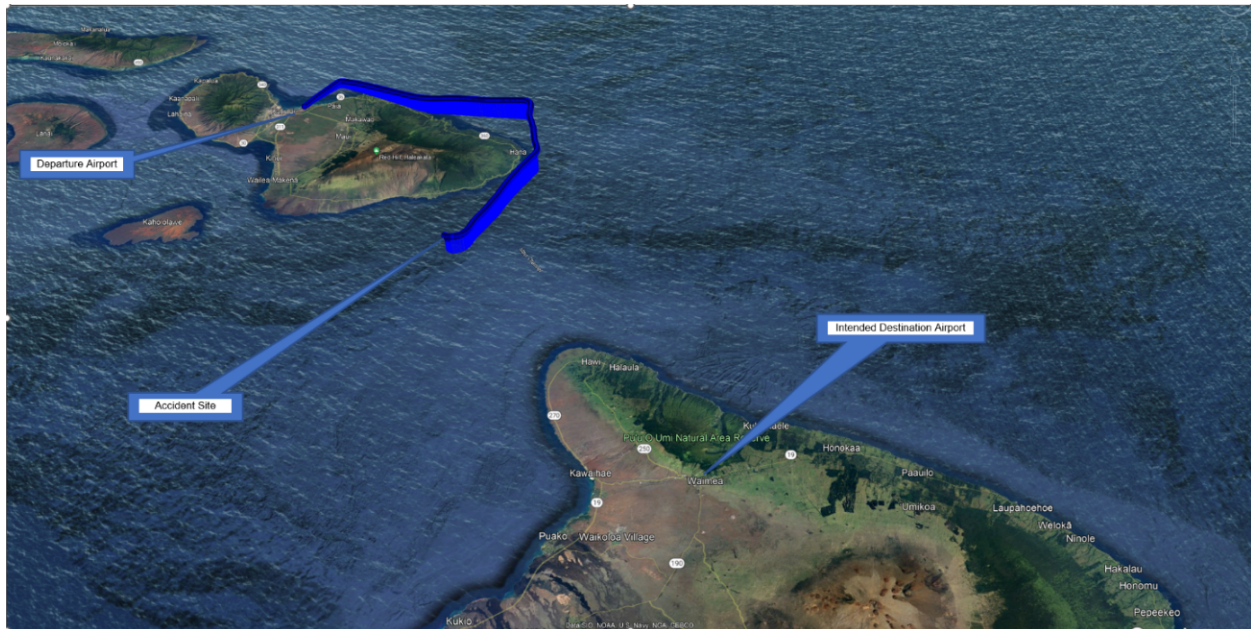
ADS-B data stopped about 10 miles south of Kaupo, near where a witness observed the accident airplane impact the water. (Figure 3)

Figure 3. Google Earth image of the flight path from the departure airport, and depicting the destination airport.

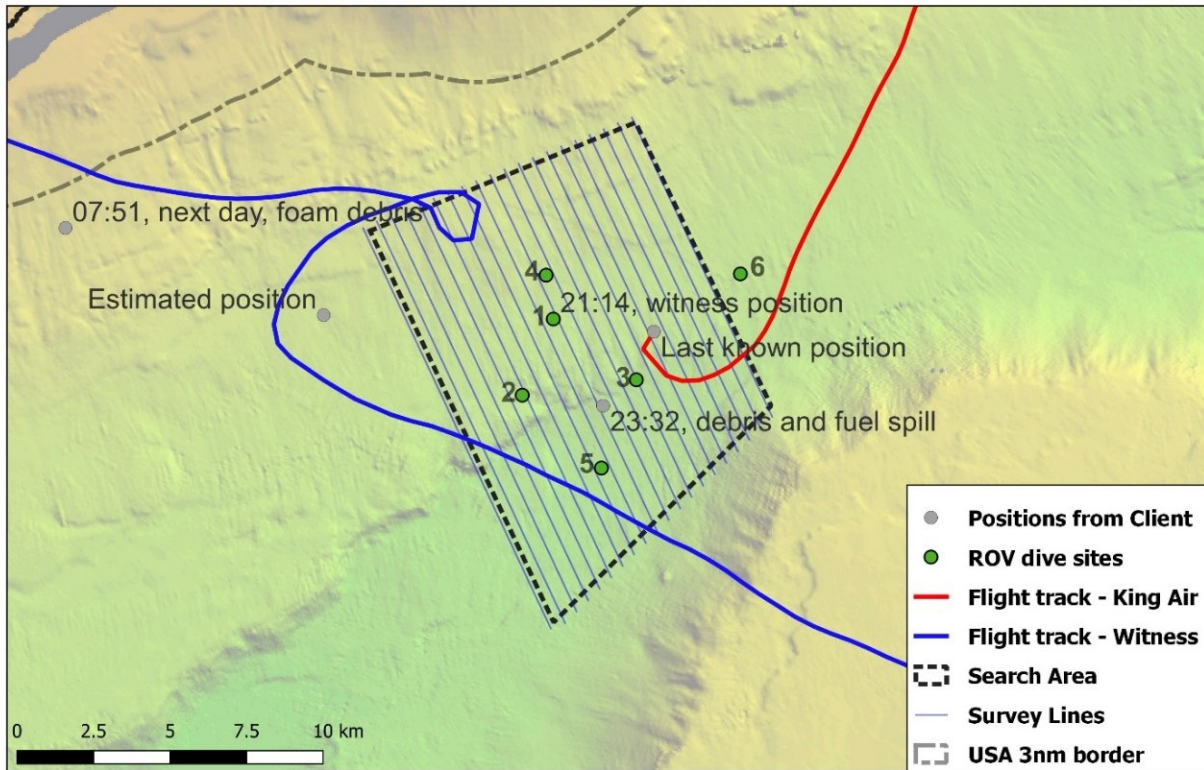
Figure 10. Map of the search grid, and points of interest. (Courtesy of Ocean Infinity)
