**Final Investigation Report**  
**on**  
**Accident to M/S Pinnacle Air Pvt. Ltd,**  
**P-68 Observer 2 Aircraft, VT-TAA**  
**on 27 March 2021**

**Amit Kumar**  
**Investigator-in-charge**

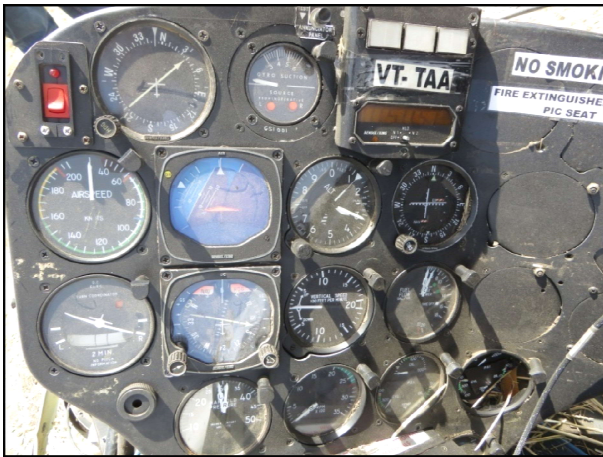
**Fig 10: View of Cockpit Instrument Panel**

- (i) The instrument panel was intact with its mounting. Both rudder pedals and control column were found damaged.

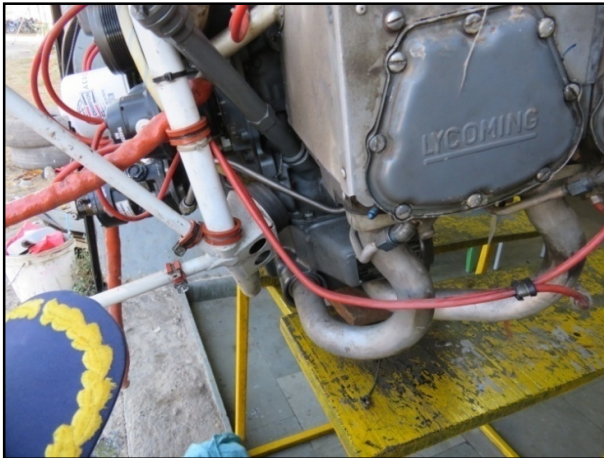
**Fig 20: Engine Number 1**

Accordingly, the left engine was inducted for Strip Examination at the DGCA authorized MRO (Maintenance Repair and Overhaul) shop. During the strip examination, the number four piston link rod bearing was found missing. In addition, broken metal pieces were found in No. 4 Cylinder head and the oil sump. The suction screen in the oil sump was found clogged with metal pieces.
