FINAL INVESTIGATION REPORT

SERIOUS INCIDENT OF PAKISTAN INTERNATIONAL AIRLINES FLIGHT PIA 605, ATR 42-500 AIRCRAFT, REGISTRATION NO. AP-BHP AT GILGIT AIRPORT ON 20TH JULY, 2019

Dated: 04th July, 2024

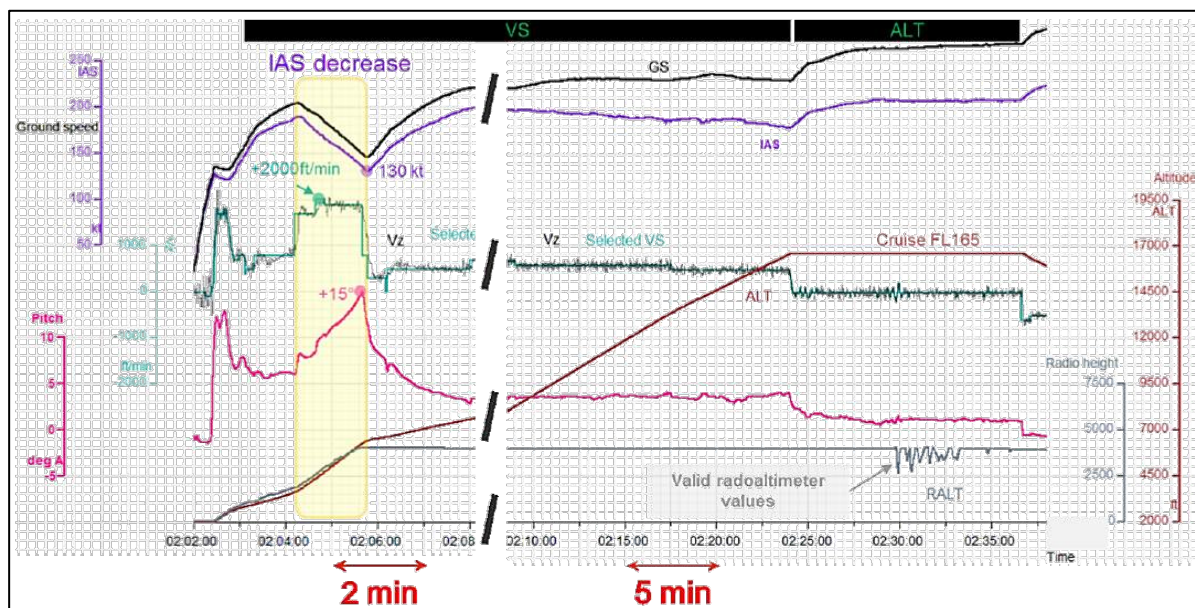
Figure 12 Flight Data (Take-off and Cruise)

2.6.1 The cruise was performed at FL165. During the cruise, the minimum RA height prior to descent was recorded as 2,636 ft; however, this is in accordance with PIA SOPs for Northern Area flights where minimum separation of 2,000 ft is mandatory due to mountains.

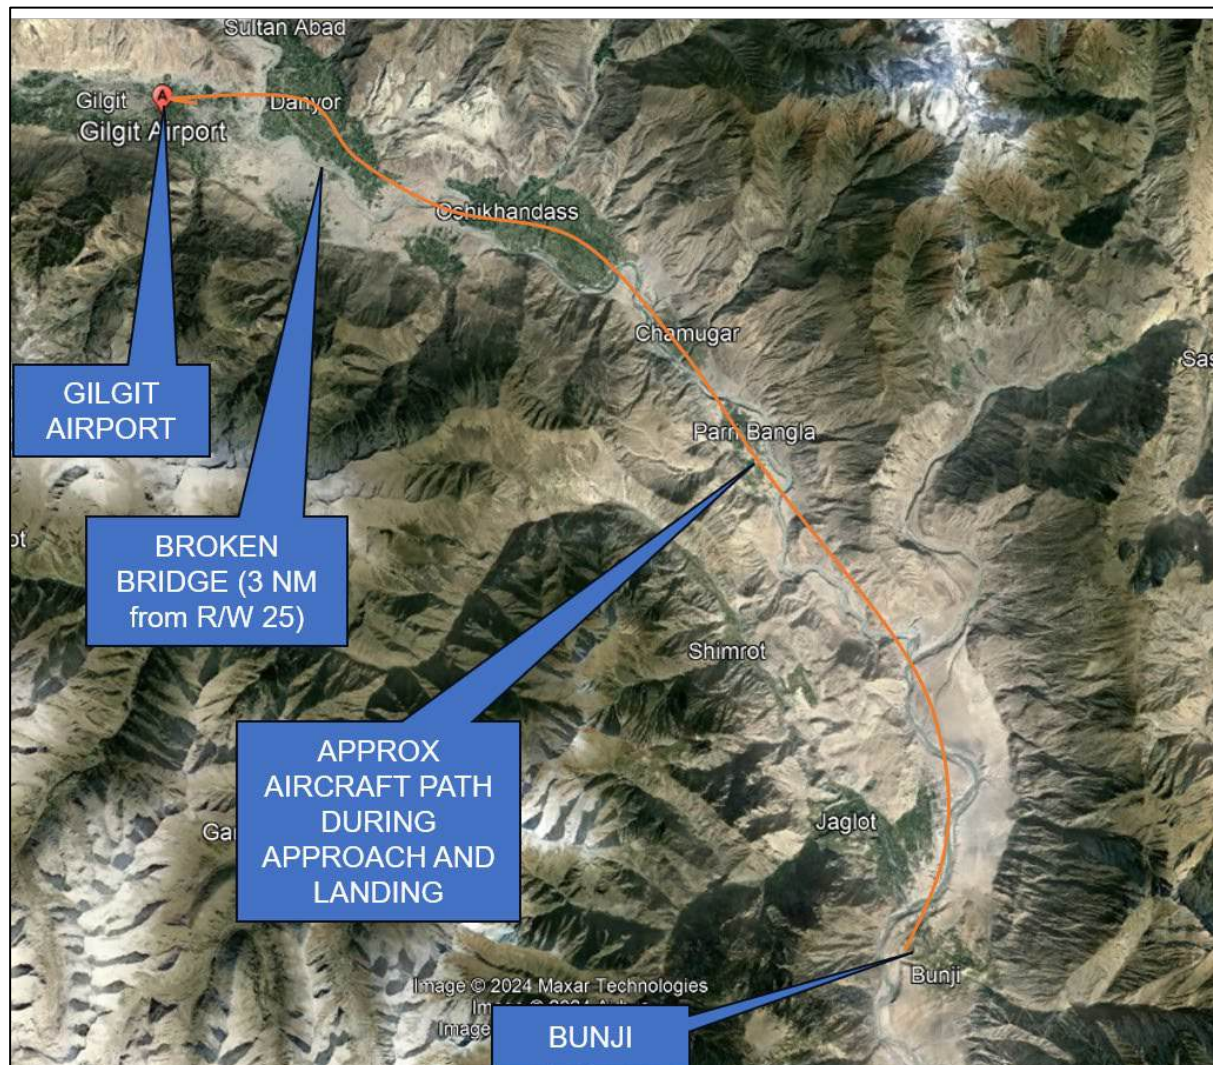
Figure 13 Approach to Gilgit Airport

2.7.1.7 Aircraft should be fully configured for landing with checklist completed by the Broken Bridge.

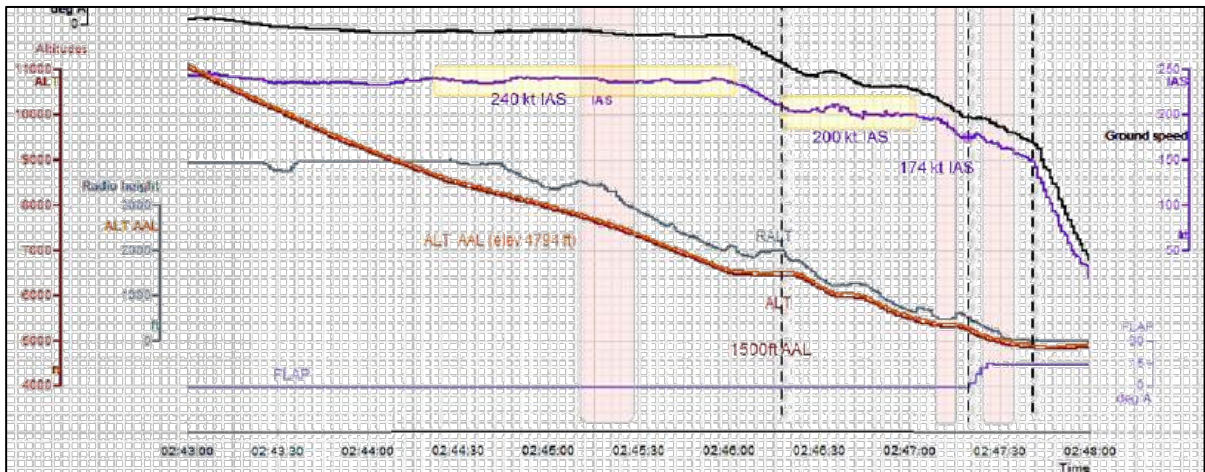
Figure 17 Flight Data (Descent)

2.7.2 For Approach to Gilgit Airport, Captain initiated the descent at 02:36:37 h with VS target set at -600 ft/min and altitude selected at 10,500 ft. During descent, the aircraft was accelerated up to 245 kt instead of maintaining 200 kt as per PIA SOPs.

2.7.3 Despite being earlier than planned ETA, the Captain still elected to maintain higher speed (contrary to SOPs) thereby compounding the problems subsequently. The FO pointed out the anomaly to Captain; however, Captain did not take any corrective action to reduce speed. Since the Captain did not pay any heed to the FO’s caution, FO did not challenge the Captain at any further point in time. This reveals a failure of Crew Resource Management (CRM) on the part of both the aircrew. The Captain disregarded the FO’s cautions completely while the FO also did not make any further attempts to correct the Captain. It also highlights the Captain’s casual approach whereby the Captain was over-confident of her abilities and disregarded any cautions or safety aspects.

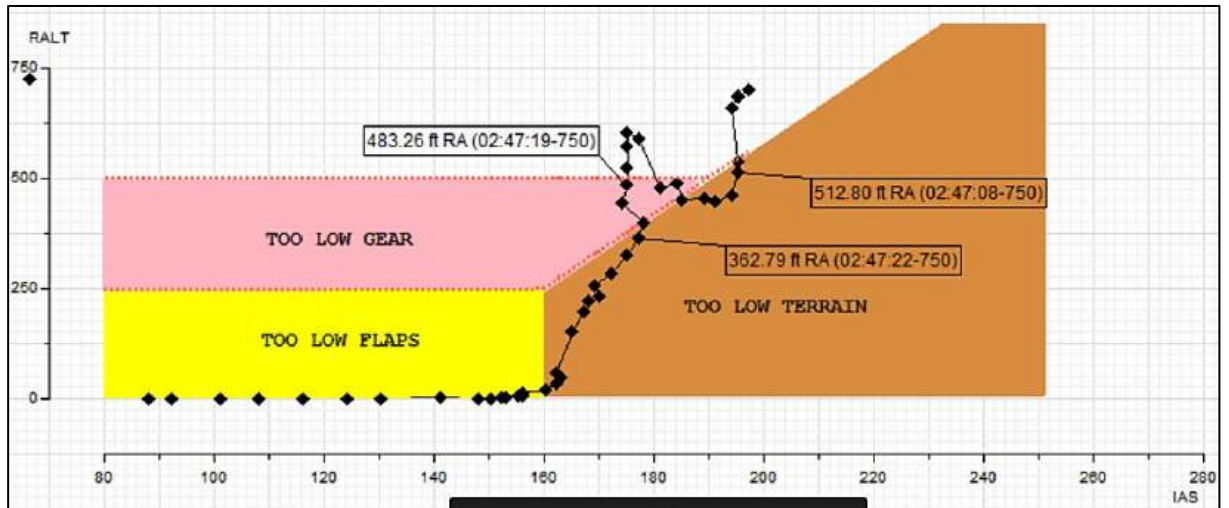
Figure 19 EGPWS Thresholds

2.8.1 The aircraft again started to descend after disengaging AP. As the aircraft was crossing 700 ft RA, the throttles were set to CL OVERRIDE position to increase drag. At 500 ft RA, the EGPWS alert and Master Warning were again triggered. The envelope and thresholds for EGPWS are as shown below: -

2.8.2 At 02:47:08 h, once the aircraft was at 513 ft AGL, the “Too Low Terrain” warning sounded for 6 s due to high Rate of Descent (ROD) of 1,200 ft/min. During the base leg, at 02:48:54 h Captain announced tail wind picking up. Although the surface wind at this time was calm as per Meteorological Reports, but gusts were present during the Approach to the R/W.

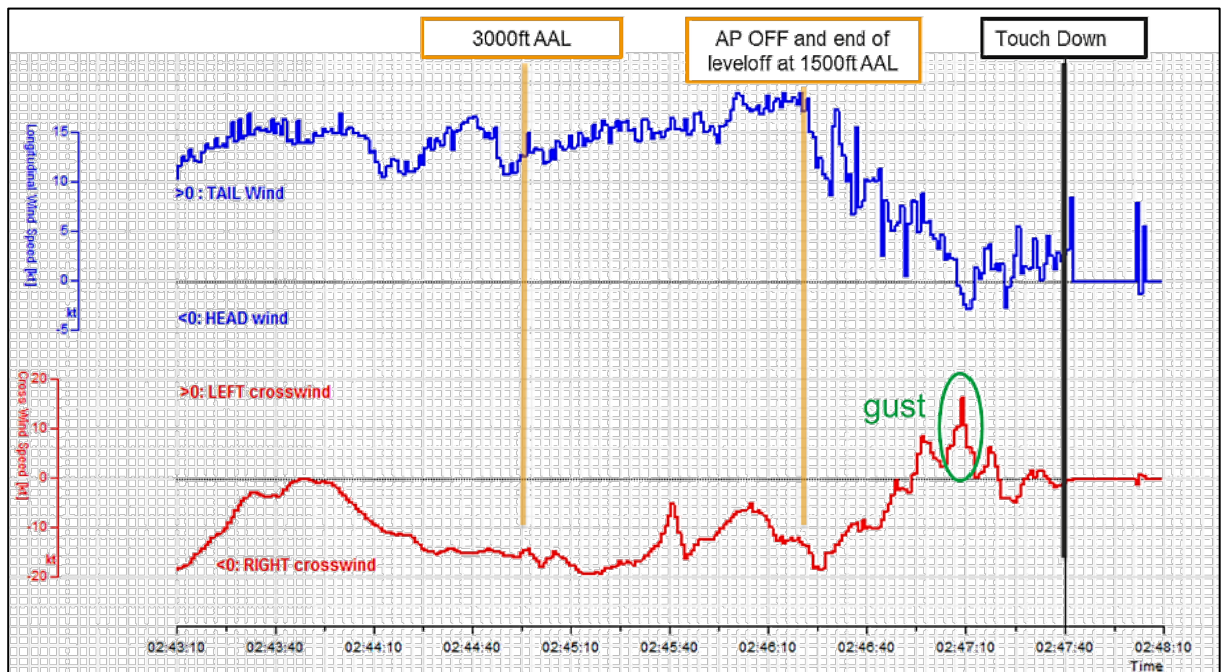
Figure 20 DFDR Data (Wind)

2.8.3 This is supported by DFDR data where the difference between TAS and GS is 1-5 kt once the aircraft is approaching R/W and on finals which indicates that wind on final Approach was not too significant and could have been catered for if the Approach had been made at correct speeds. Thus, while the tail wind may have contributed to increased float and Landing distance, it was not so significant that it could not have been catered by adhering to the correct speeds for Approach.

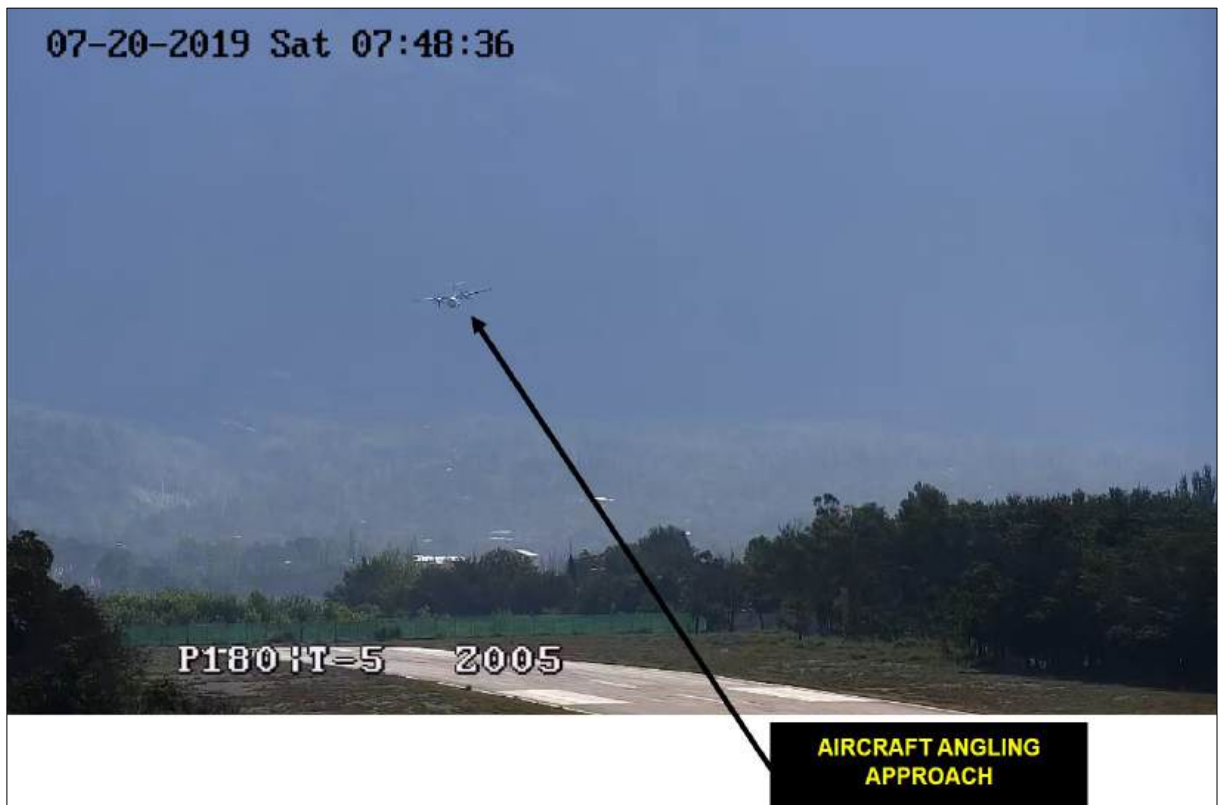
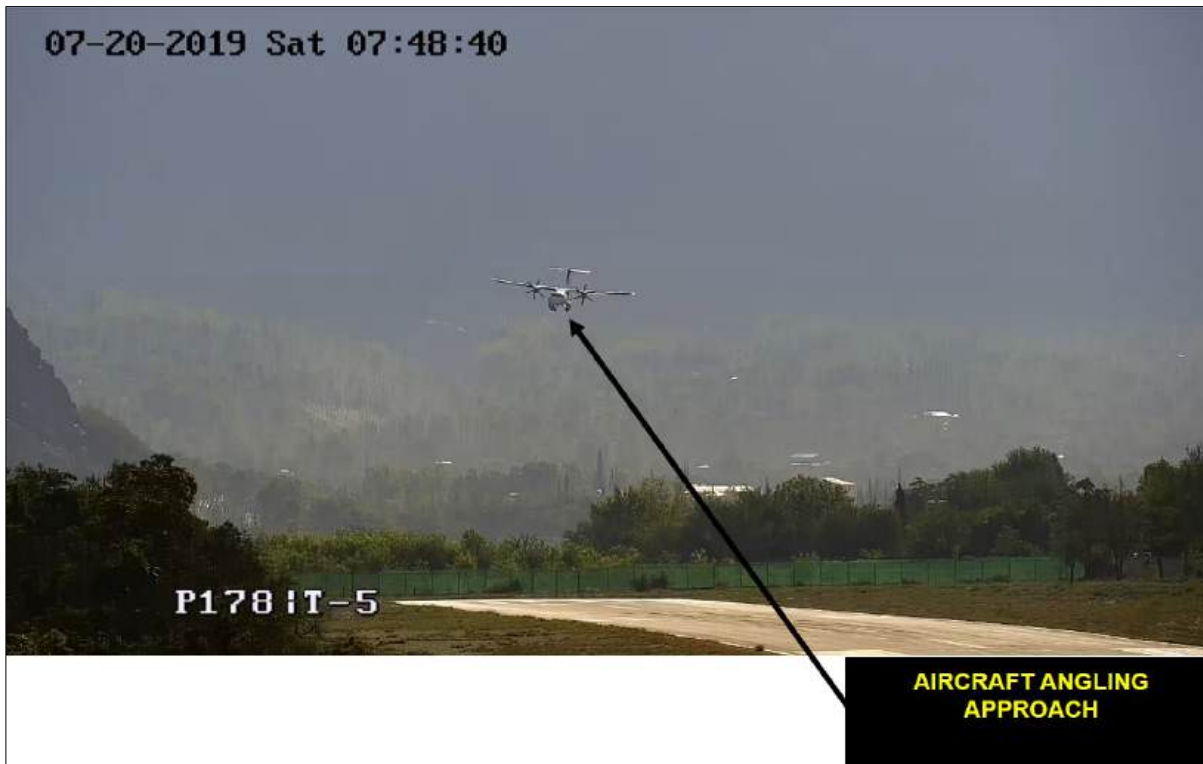
2.9.1 As per PIA SOPs, the aircraft must be in landing configuration by minimum 3 NM from the R/W (abeam Broken Bridge). However, due to higher speed, the aircraft could not be configured for Landing at the designated point prior to base leg or even during base leg. At 02:47:14 h, the “Too Low Gear” warning sounded for 2 s due to incorrect configuration once the aircraft was at 488 ft RA at a speed of 184 kt. The same warning was again triggered due to the same reason at 02:47:20 h when the aircraft was at 500 ft RA at 175 kt. Despite repeated warnings, the Captain made no attempt to discontinue the Approach, or take any remedial measures and no actions were initiated on EGPWS warnings. The aircraft is supposed to be in correct Landing configuration prior to commencement of base leg; however, L/G were lowered upon initiation of base turn at a height of 442 ft AGL with remaining distance to R/W 0.57 NM.

2.9.3 This action resulted in reduced track length and lesser speed depletion. As the aircraft was heading towards the R/W, the aircraft was brought to partial Landing configuration. The Flaps were selected to 15° at 175 kt (Speed for Flaps 15°: 180 kt) and 491 ft AGL followed immediately by lowering of L/G at 442 ft AGL. The L/G, however, were lowered at 174 kt whereas the speed for L/G lowering is 170 kt. The aircraft veered right and then turned left to align itself with the R/W. At 02:47:25 h, another EGPWS warning triggered when the aircraft crossed the threshold of 500 ft AGL with L/G still not in down and locked position. Despite this EGPWS warning at such a low height, no attempt was made by the Captain to Go-Around from the Approach. The Flaps came down to 15° position at 257 ft AGL whereas the L/G attained down and locked position only once the aircraft was rolling out on R/W heading at an altitude of approximately 50 ft AGL at a speed of 162-163 kt.

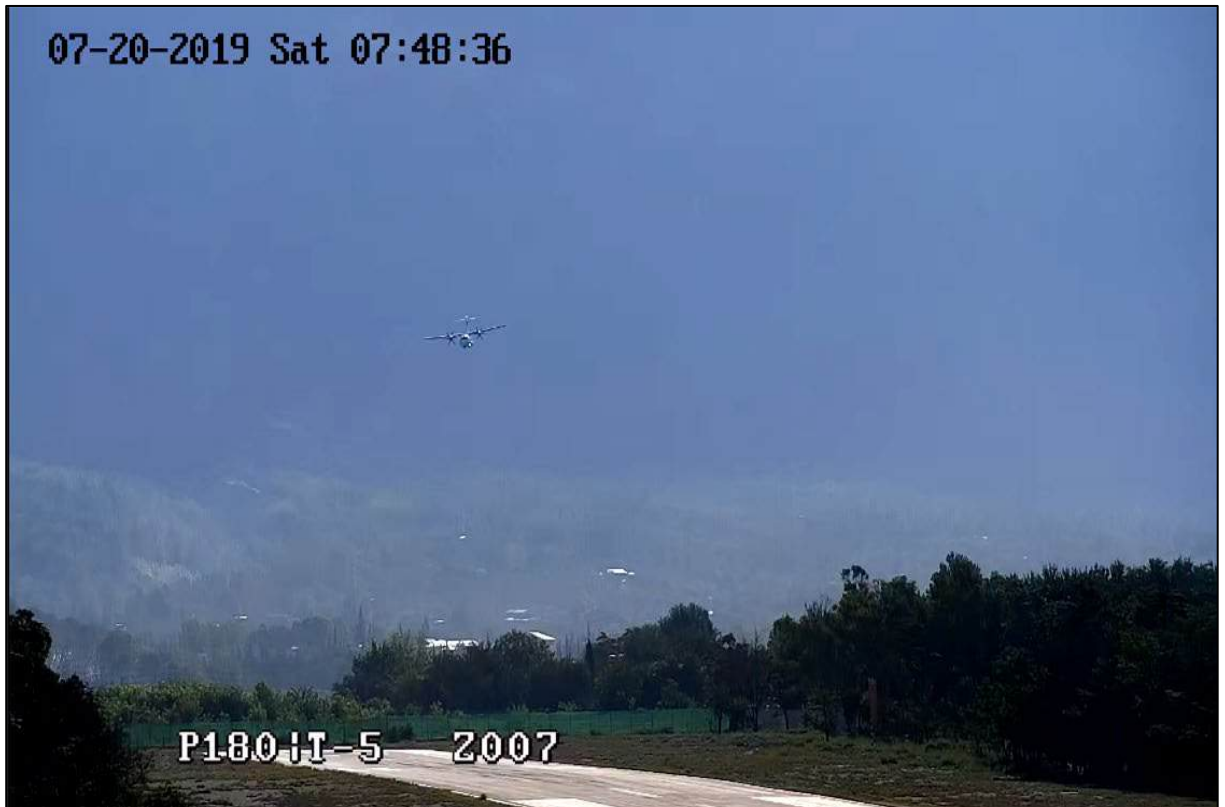
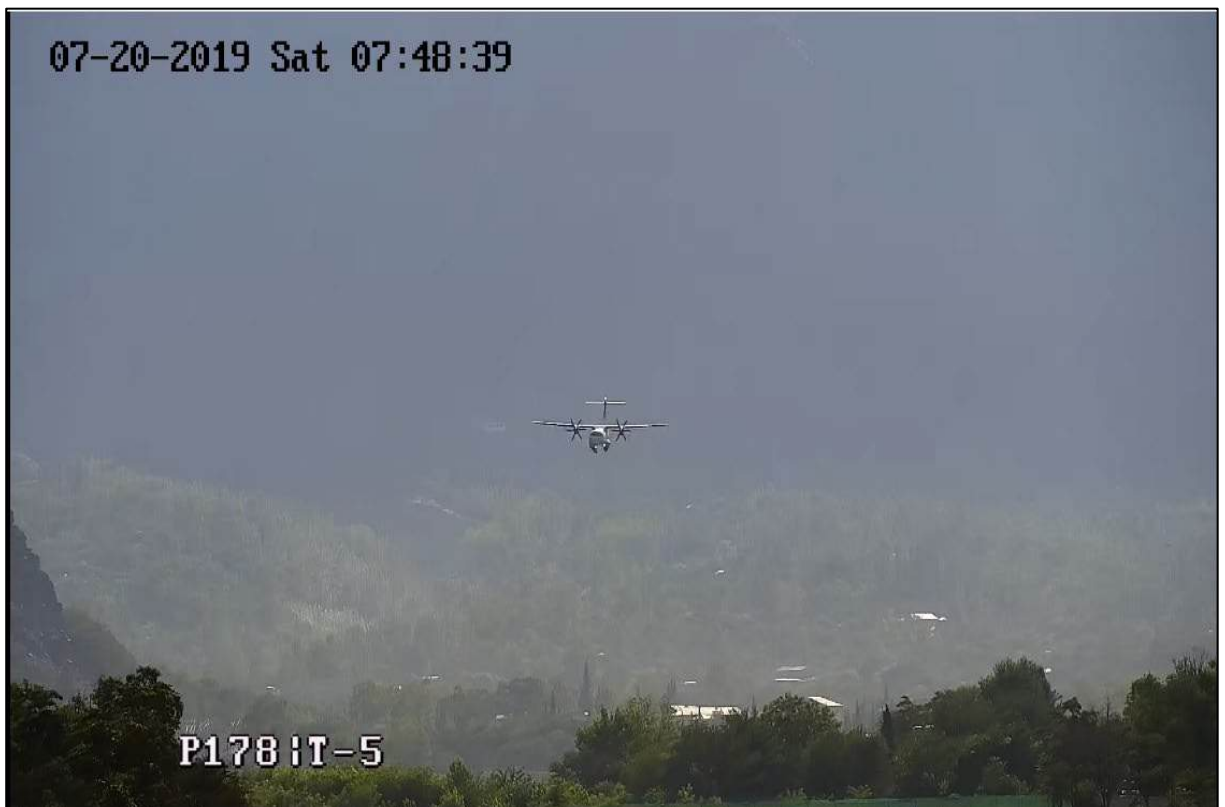
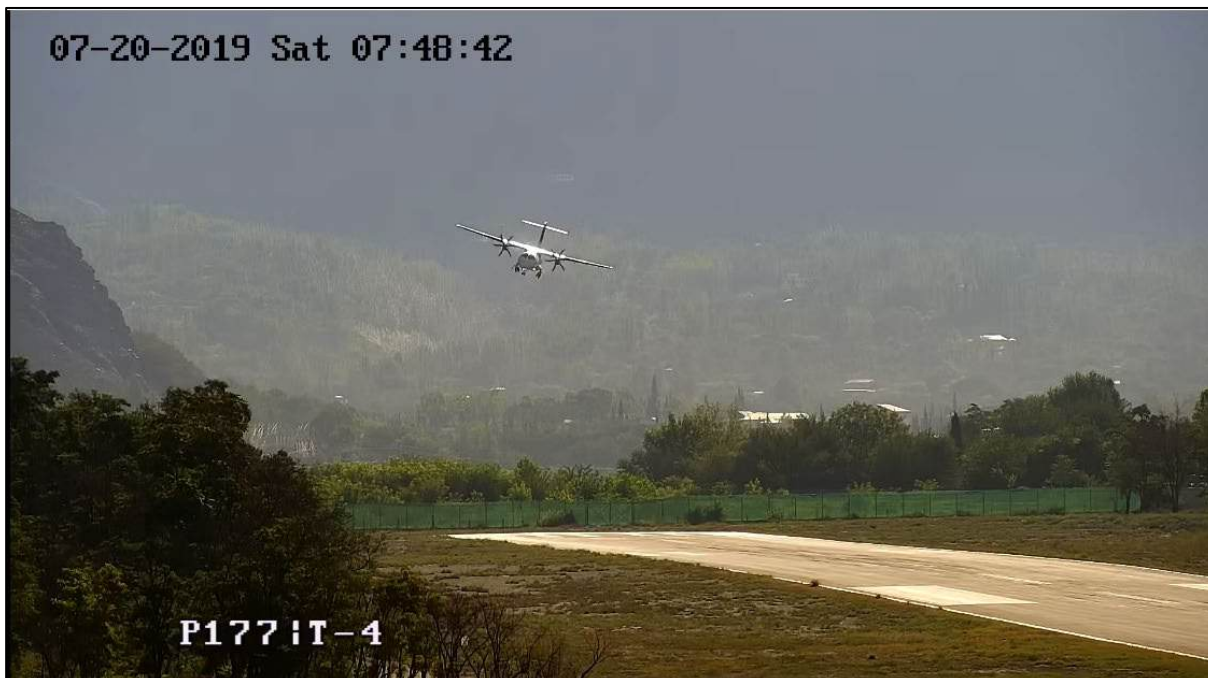
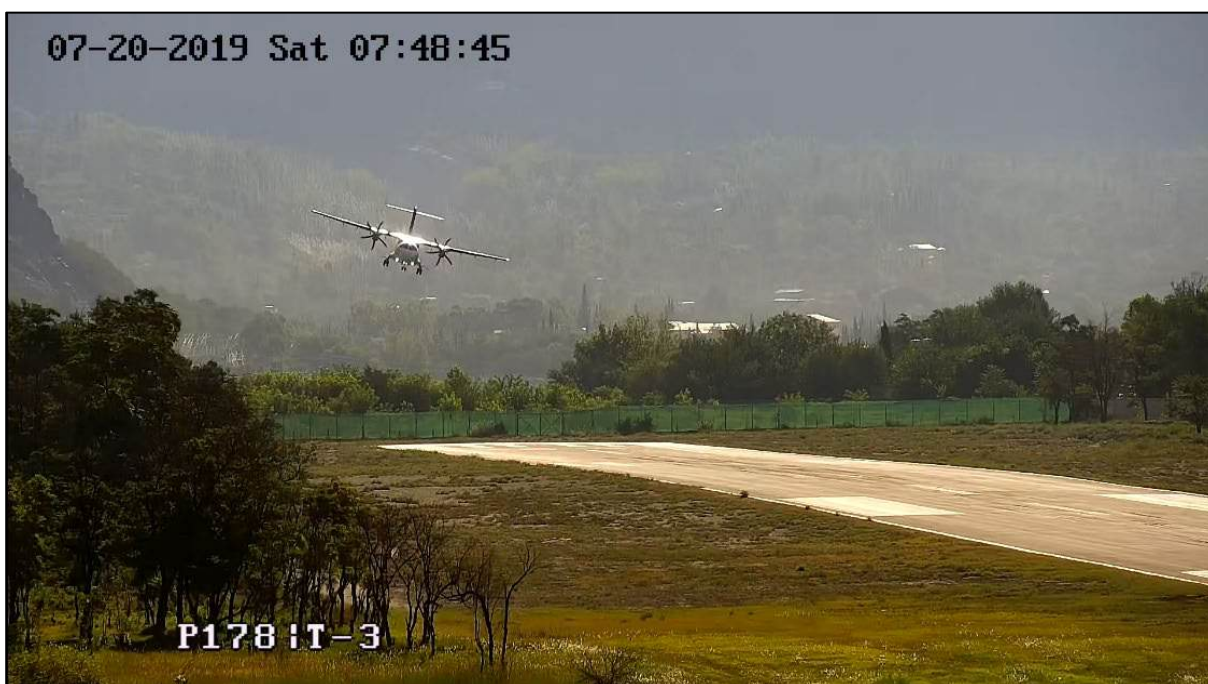
2.10.1 After selecting the Flaps to 15° and L/G lever down, the aircraft was put in left bank at a height of 230 ft AGL to align with the R/W. As the L/G became down & locked at approximately 50 ft AGL, the aircraft continued to remain in bank and rolled out in line with R/W heading at a height of approximately 30 ft AGL, upon entering the R/W. Just short of overflying the R/W threshold in left bank, EGPWS "Too Low Terrain" warning was triggered with aircraft at 55 ft RA and ROD 800 ft / min.

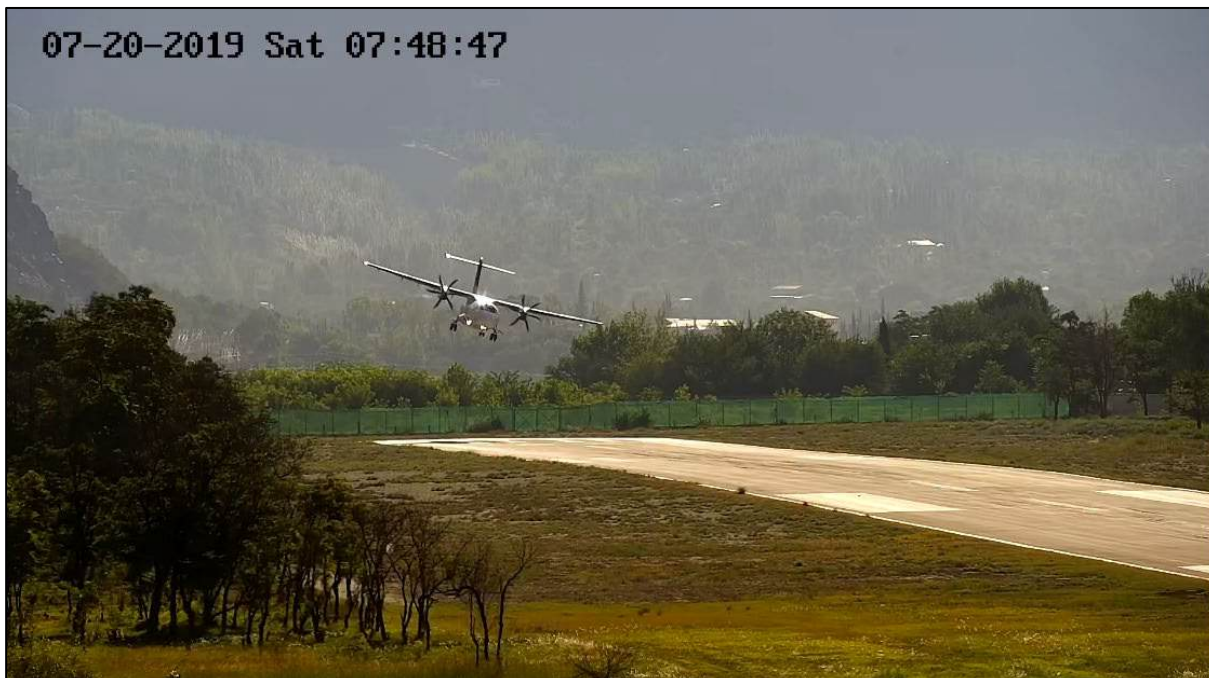
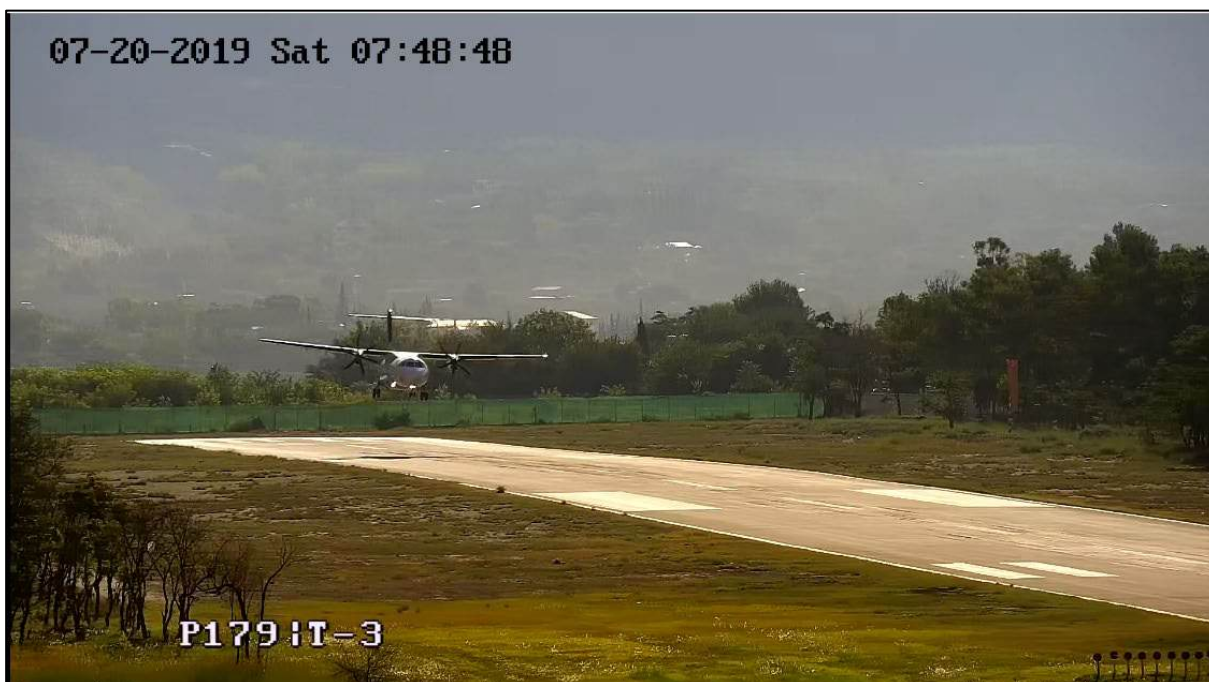
2.10.2 As a result, full Flaps could not be lowered since the speeds for selecting 25° and 35° Flaps are 160 kt and 150 kt respectively. Owing to a combination of incorrect / reduced base turn track, late Landing configuration and partial Flaps, the speed depletion rate on base turn and final Approach remained low and correct Landing configuration could not be attained prior to touchdown.

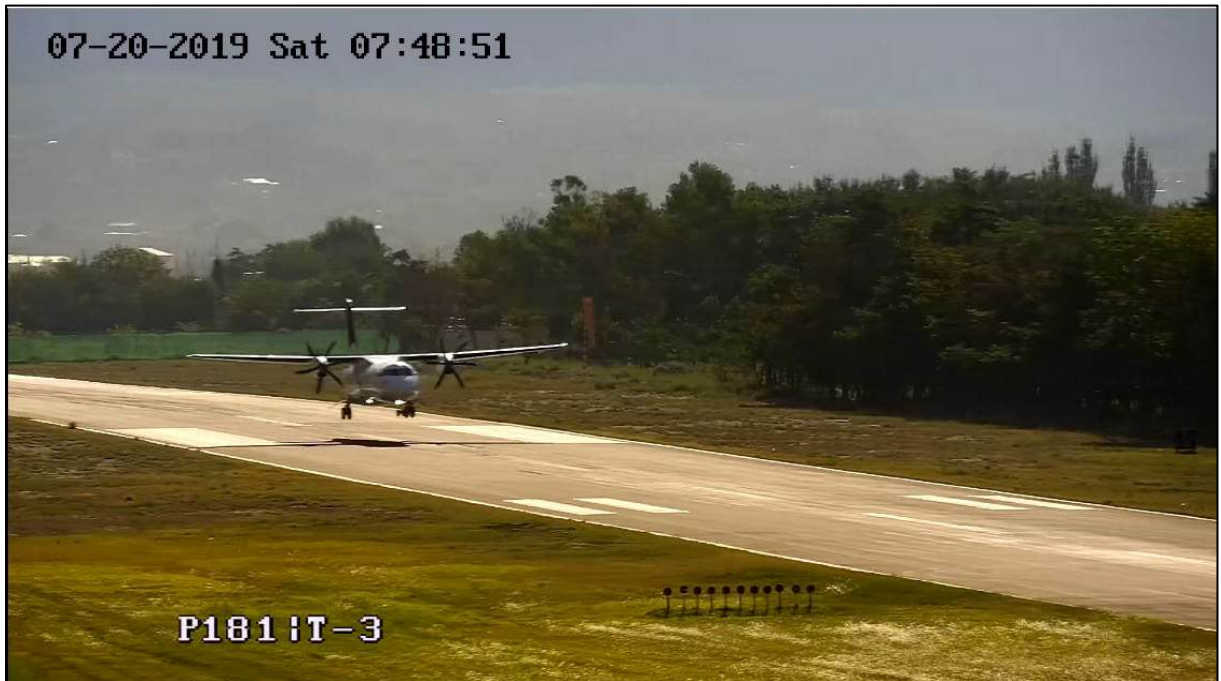
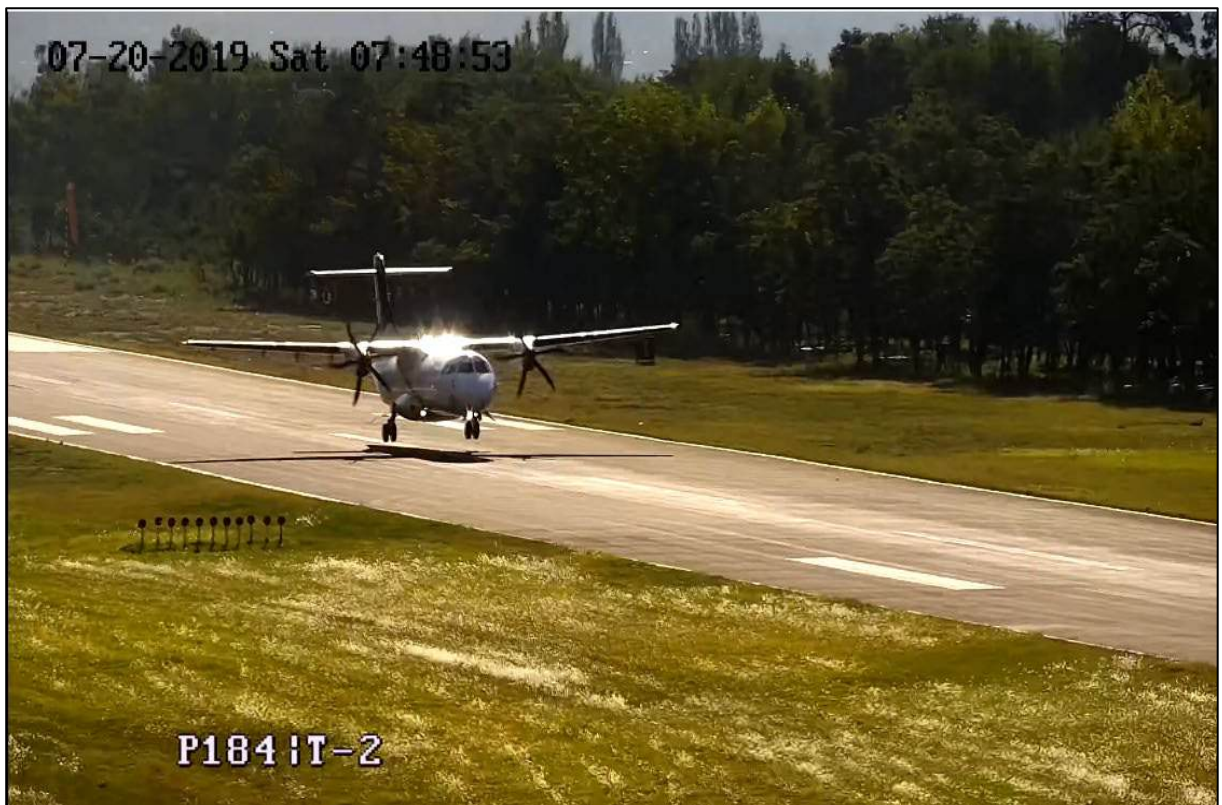
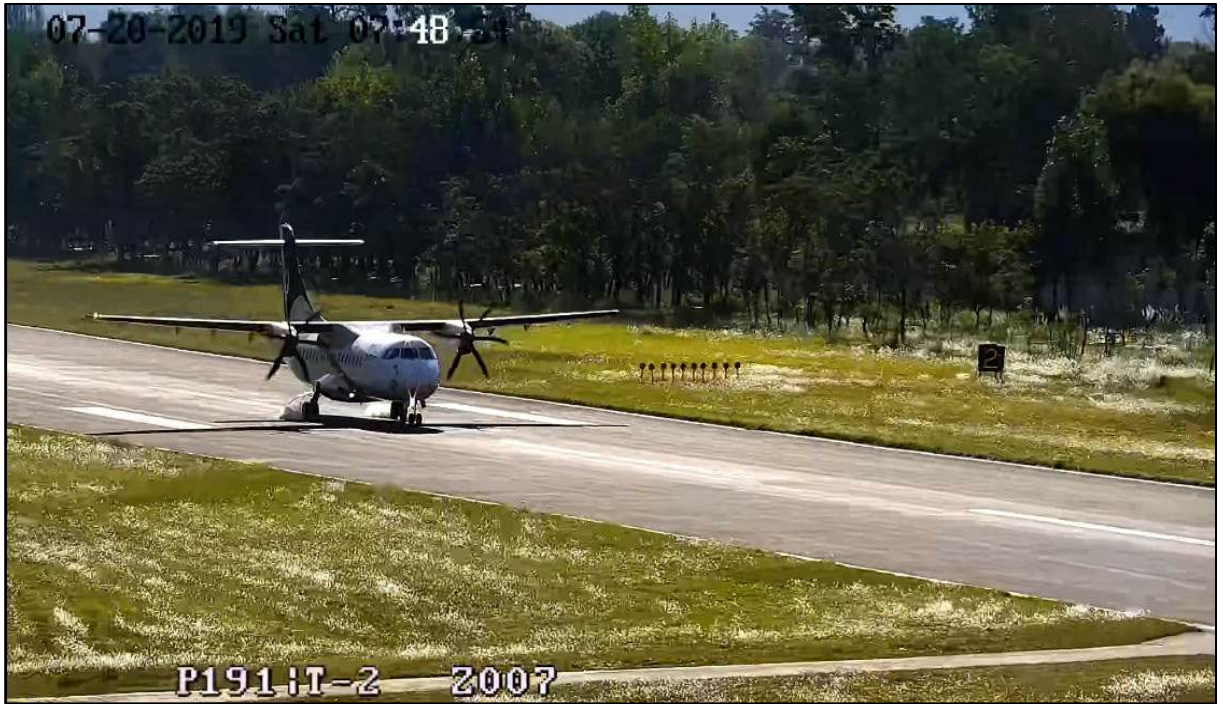
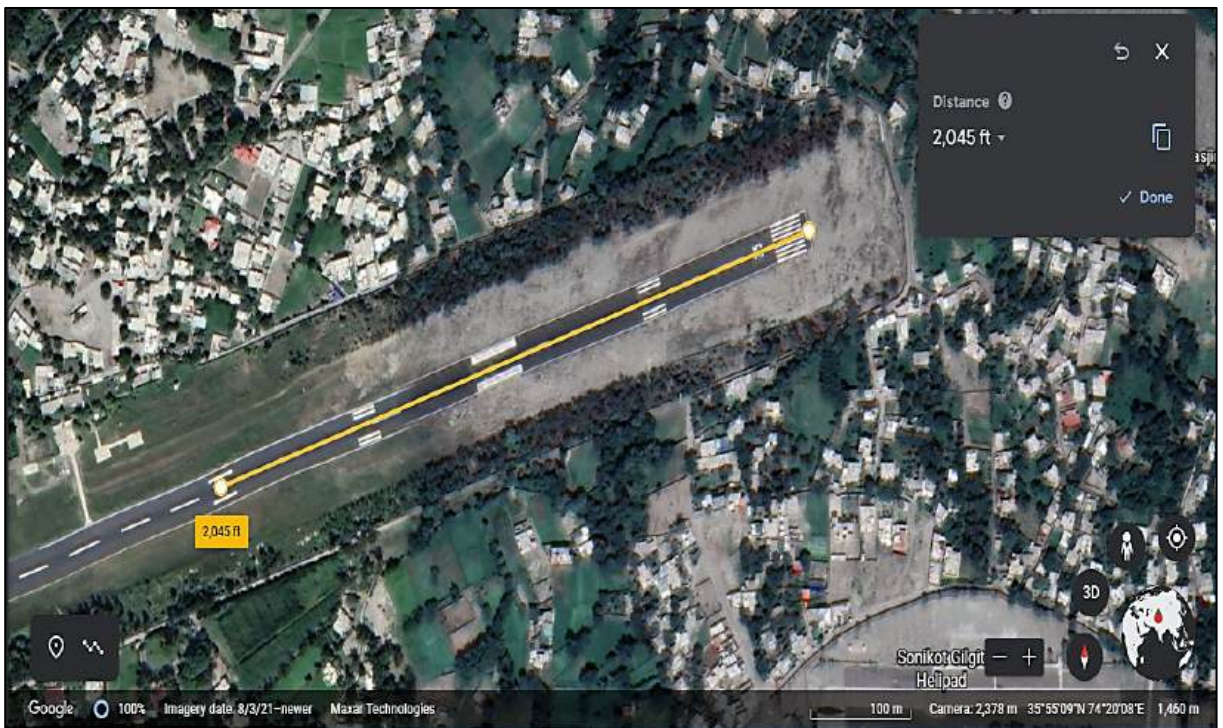
touchdown by the Captain approximately 2,000 ft down the R/W at 150 kt (Ground speed: 170 kt), leaving approximately 3,400 ft for the aircraft to decelerate to taxi speed. As the aircraft touched down, the Captain retarded the throttles initially to reverse but then set them to just below Ground Idle (GI) position. Meanwhile the FO pushed the aircraft nose down on his controls. However, despite Landing at high speed, Captain did not use Thrust Reversers. The throttles must be held back in Reverse position otherwise they return to GI position upon releasing them. The Captain thus only applied brakes to stop the aircraft.
