# Collision with terrain Piper PA-31P-350 Mojave VH-PGW

6 km north-west of Bankstown Airport, New South Wales | 15 June 2010

**ATSB Transport Safety Report**  
Aviation Occurrence Investigation  
AO-2010-043  
Final

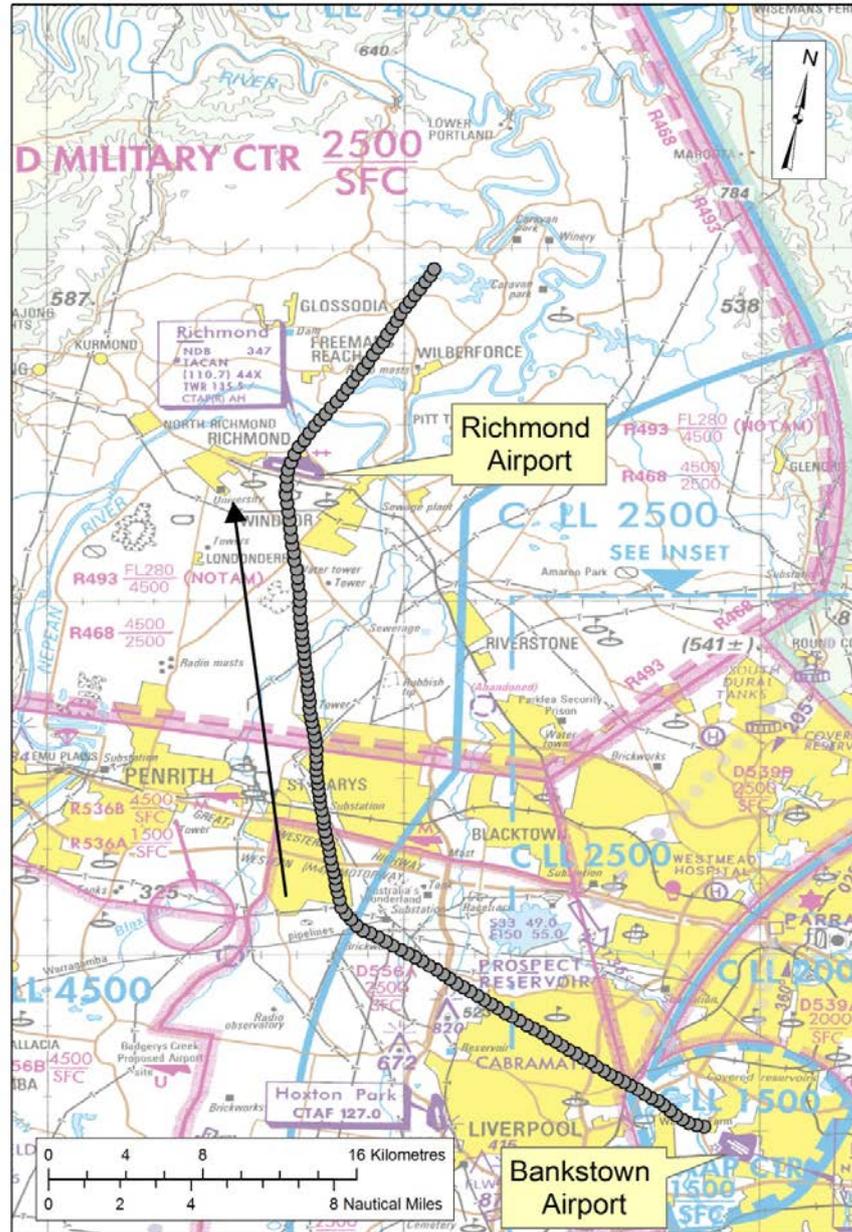
**Figure 1: Aircraft flight path from takeoff to the cessation of the climb**

Time	Event
0752:20	The aircraft ceased climbing when it was about 6 NM (11 km) north of Richmond Airport (Figure 1). Altitude: 7,600 ft Derived airspeed: 135 kts

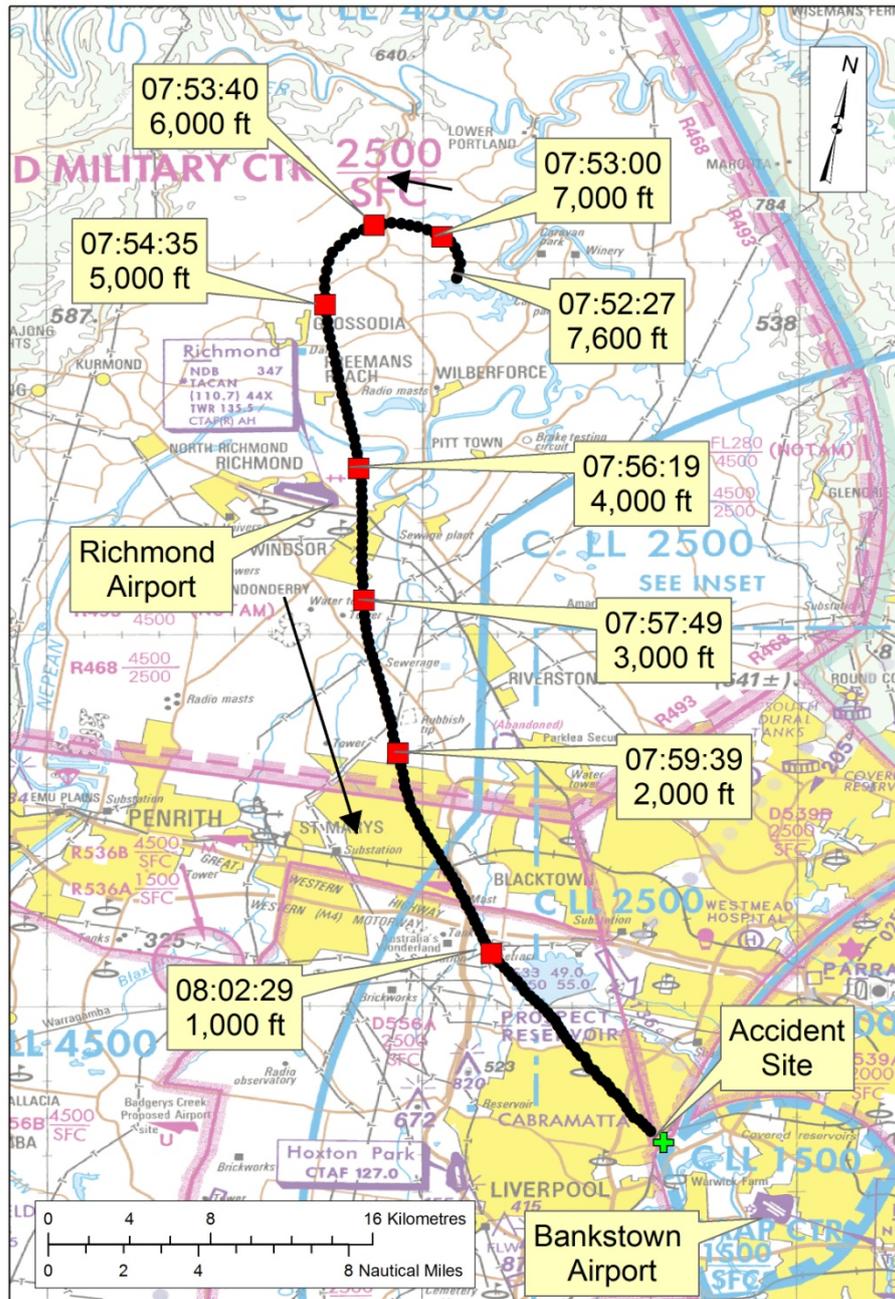
Figure 2: Aircraft's flightpath from 7,600 ft to impact

The system track data relating to the aircraft's position, groundspeed and altitude was logged every 5 seconds. The logged data was used to determine the radar track and altitude following the aircraft's departure from Bankstown Airport. Figures 1 and 2 depict the recorded track of the aircraft relative to Richmond and Bankstown Airports.
