FINAL
KNKT.12.04.08.04

Aircraft Accident Investigation Report

**PT. ASI Pudjiastuti Aviation
Pilatus Porter PC-6 ; PK-VVQ
Melak Area , East of Kalimantan
East of Kalimantan
Republic of Indonesia**

25 April 2012

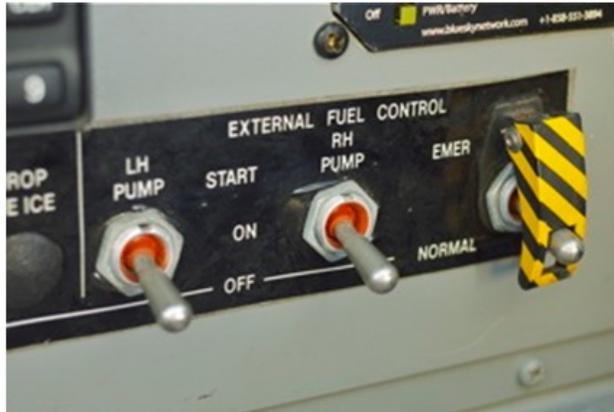
Figure 5: Auxiliary fuel control

- There are 4 annunciator lights associated with the auxiliary fuel system (2 for each side). The GREEN “LF Pump” and “RF Pump” illuminate during pump operation when fuel is transferred. The AMBER “Fuel Flow” annunciators illuminate when the pumps auto-stop (when either no fuel remains in the auxiliary tanks or the main tanks are near full).

The lack of fuel transferred from external auxiliary tanks to the main tank caused the main tank to run dry and caused a loss of fuel feed to the engine, which caused the engine flame out.
