ACCIDENT

Aircraft Type and Registration:	Saab-Scania SF340B, G-LGNL	
No & Type of Engines:	2 General Electric CT7-9B turboprop engines	
Year of Manufacture:	1991 (Serial no: 340B-246)	
Date & Time (UTC):	2 January 2015 at 0833 hrs	
Location:	Stornoway Airport, Isle of Lewis	
Type of Flight:	Commercial Air Transport (Passenger)	
Persons on Board:	Crew - 3	Passengers - 26
Injuries:	Crew - None	Passengers - None
Nature of Damage:	Extensive damage to the nose landing gear, powerplants and underside of the aircraft	
Commander's Licence:	Air Transport Pilot's Licence	
Commander's Age:	46 years	
Commander's Flying Experience:	3,880 hours (of which 3,599 were on type) Last 90 days - 98 hours Last 28 days - 28 hours	
Information Source:	AAIB Field Investigation

Synopsis

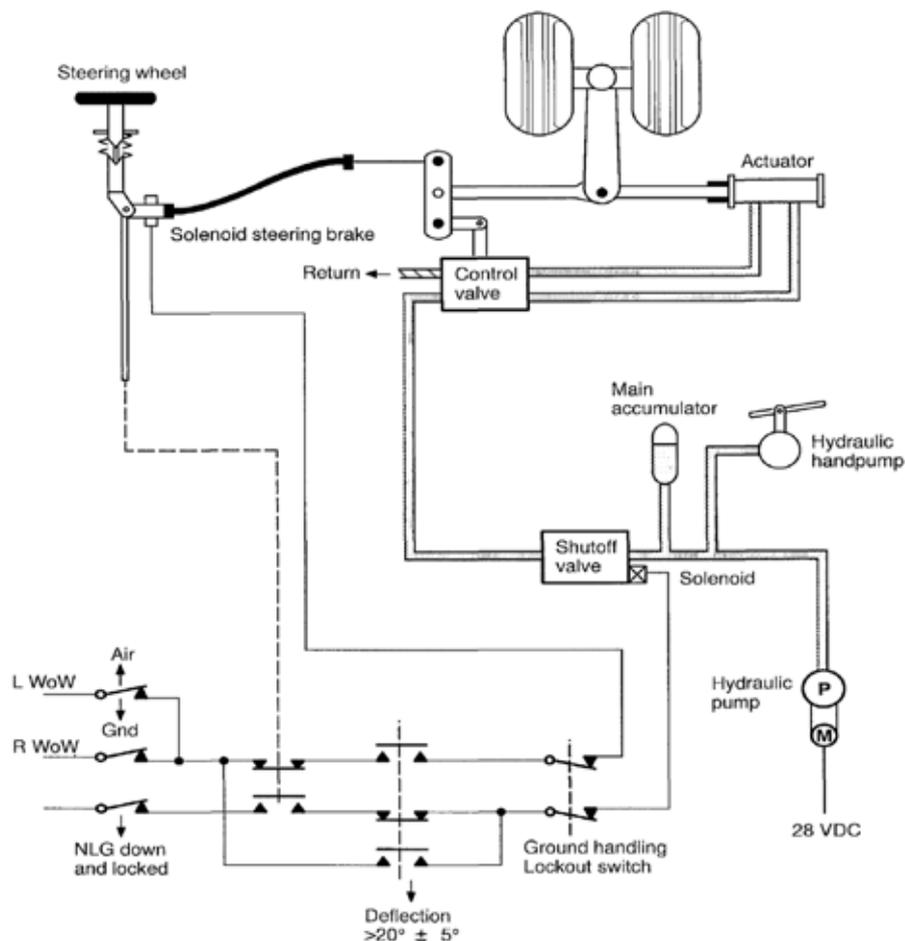
Figure 4

Schematic of NWS (from Aircraft Operating Manual)

Due to damage sustained, it was not possible to conduct a detailed check of the steering system and its rigging. However, a visual examination of the system did not reveal any pre-existing defects.
