Interim Report

Type of Occurrence:	Accident
Date:	30 September 2015
Location:	Saarbrücken
Aircraft:	Airplane
Manufacturer / Model:	Bombardier Inc./ DHC-8-402
Injuries to Persons:	None
Damage:	Aircraft severely damaged
Other Damage:	None
Information Source:	Investigation by BFU
State File Number:	BFU 15-1354-AX
Published:	December 2015

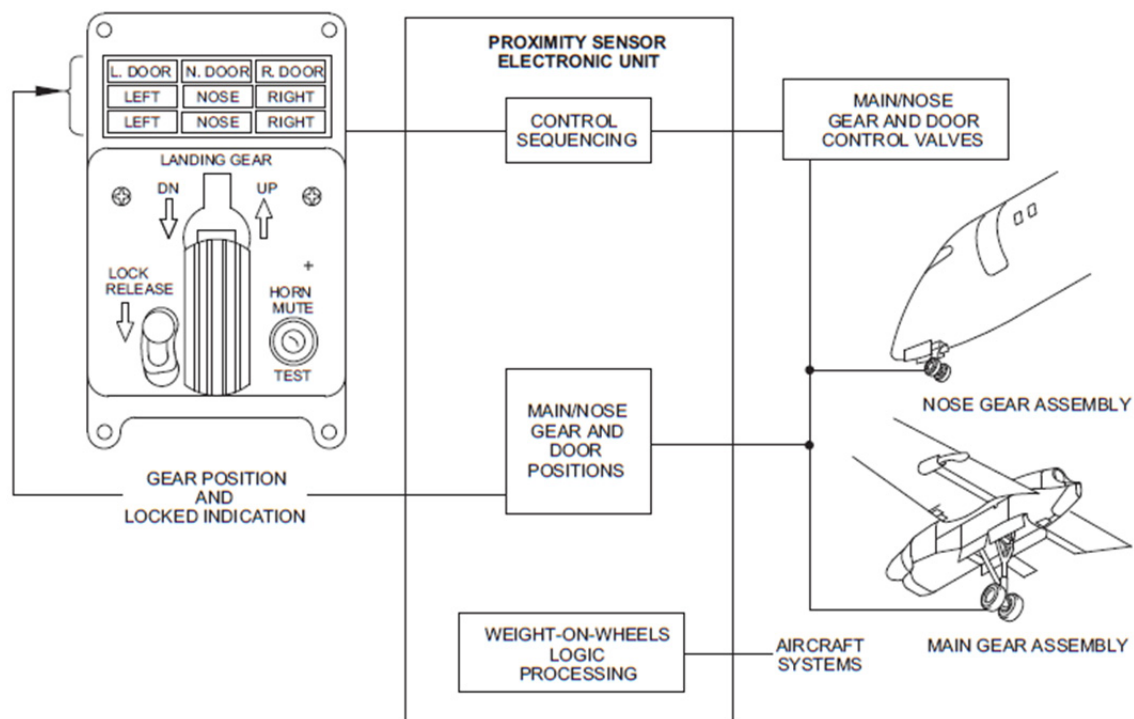
When the landing gear selector lever is selected to the UP position, hydraulic pressure from No. 2 system is applied to the retract side of the system (Figure 12.13-19). This opens the nose gear forward doors and retracts the nose gear, it also opens the main gear aft doors and retracts the main gear. The aft nose gear doors are mechanically linked and close with the retracting nose gear. After nose gear retraction, the forward nose gear doors close hydraulically. The forward main gear doors are mechanically linked and close with the retracting main gear. After main gear retraction, the aft main gear doors close hydraulically.

The advisory light sequence during retraction starts with the LEFT, NOSE and RIGHT red unsafe lights and the amber selector handle light coming on. At the same time, the green LEFT, NOSE and RIGHT lights go off to show the gear is not locked down. The amber door advisory lights come on to show the hydraulically operated gear doors are open. When the landing gear is retracted and locked in the up position, the amber selector handle light and red advisory lights go out. Finally, the amber gear door advisory lights go out to show all the hydraulic gear doors have closed. No advisory lights should be on if the gear is up correctly. The main and nose gear are held in the up position mechanically with uplocks, and hydraulic pressure is removed from the system.
