# AIRCRAFT ACCIDENT REPORT

**BOEING 727, N68650**

**LANSEAIR INC., CESSNA 310, N3121S**

**MIDAIR COLLISION**

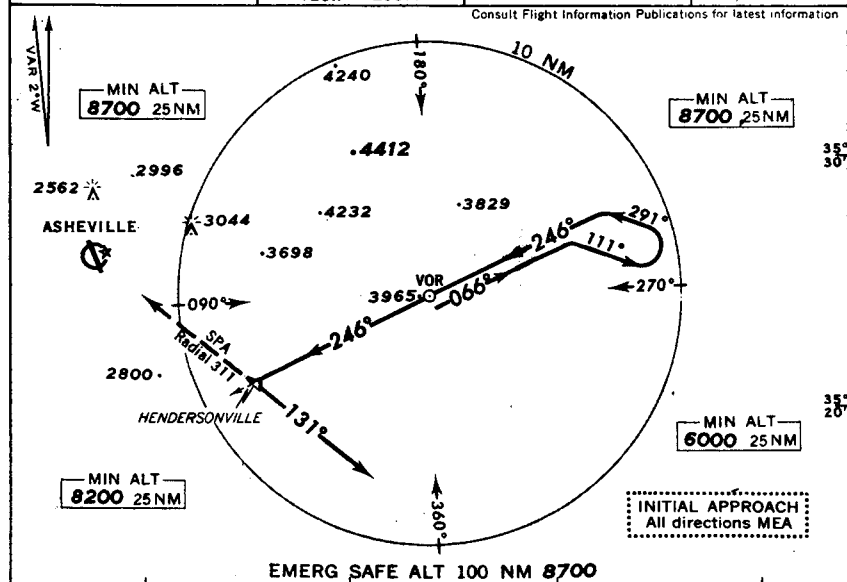
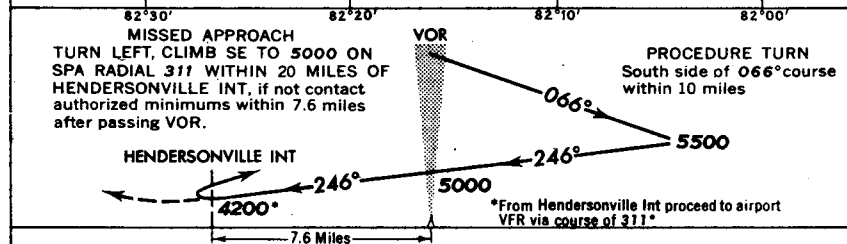
# INST APCH PRO (FAA) U.S. COAST AND GEODETIC SURVEY ASHEVILLE MUNICIPAL AIRPORT ASHEVILLE, N. C.

| ASHEVILLE<br>APPROACH CONTROL<br>125.3 257.8 | ASHEVILLE RADIO<br>112.2 AVL :<br>122.2 123.6<br>126.7 255.4 | ASHEVILLE TOWER<br>121.1 257.8<br>GROUND CONTROL 121.9 348.6 | NO RADAR |

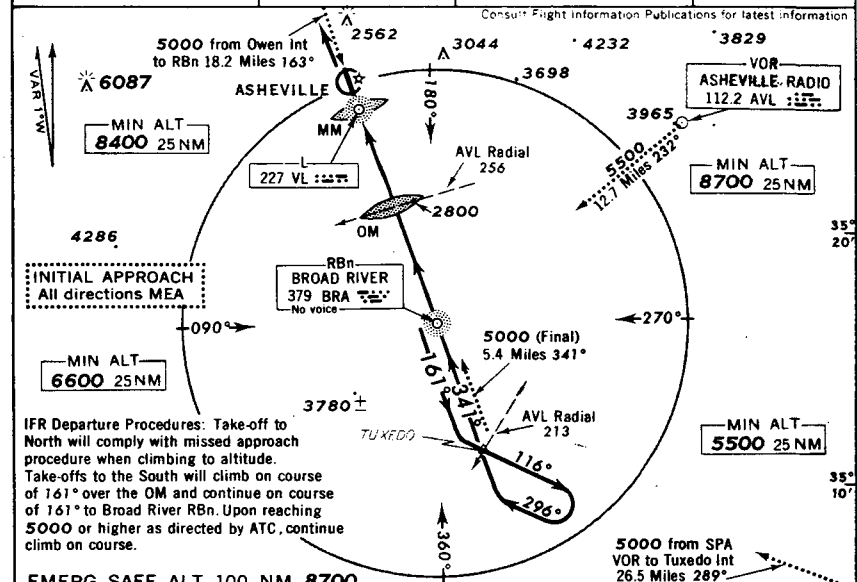
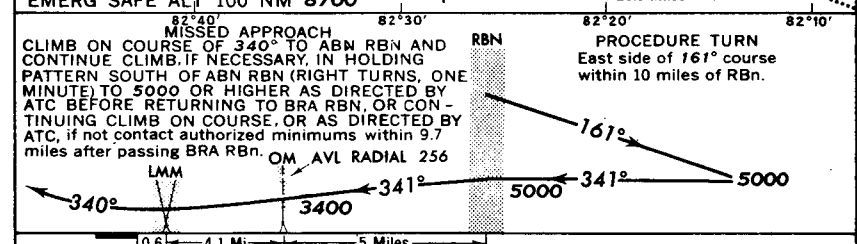
# INST APCH PRO (FAA) U.S. COAST AND GEODETIC SURVEY ASHEVILLE MUNICIPAL AIRPORT ASHEVILLE, N. C.

| ASHEVILLE<br>APPROACH CONTROL<br>125.3 257.8 | BROAD RIVER<br>379 BRA :<br>No voice | ASHEVILLE TOWER<br>121.1 257.8<br>GROUND CONTROL 121.9 348.6 | NO RADAR |

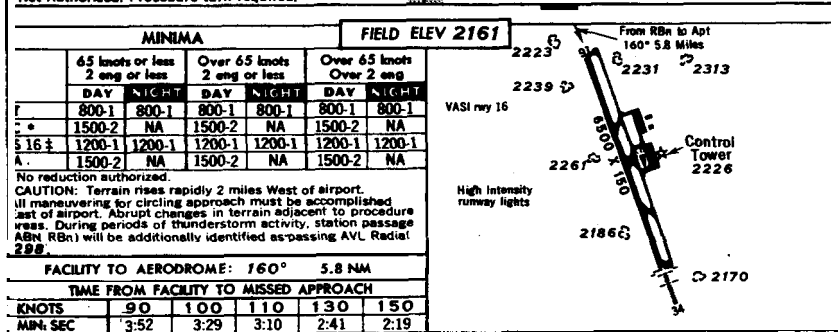
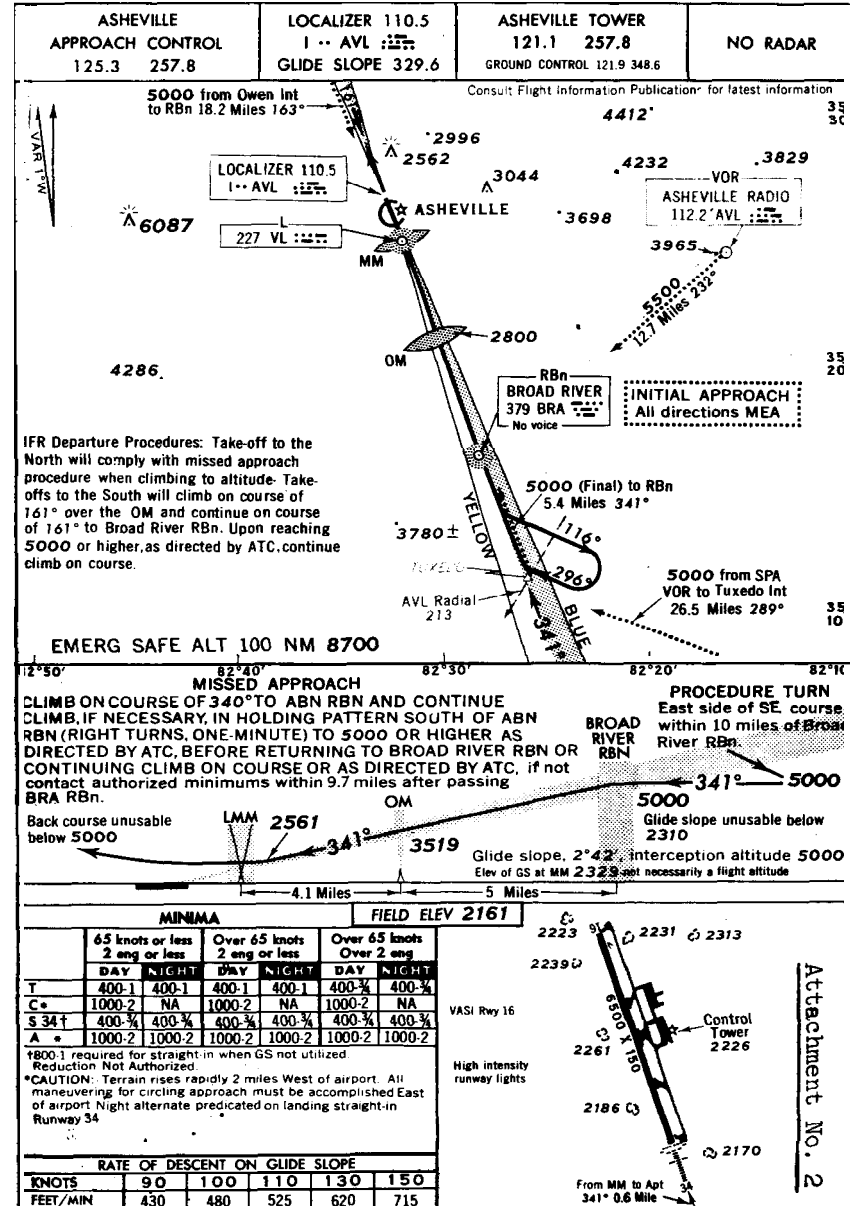
Attachment No. 2

AL-5061-ADF-1 35°26'N - 82°32'W ASHEVILLE, N. C. ASHEVILLE MUNICIPAL AIRPORT
