SOUTH AFRICAN CIVIL AVIATION AUTHORITY

ACCIDENT REPORT EXECUTIVE SUMMARY

Date of Accident	06 December 1999	Time of Accident	0506z	
Aircraft Registration	ZS-OJY	Type of Aircraft	Piper PA31-350	
Pilot-in-command Licence Type	Commercial		Licence Valid	Yes
Pilot-in-command Flying Experience	Total Flying Hours	1444:55	Total Hours on Type	445:25
Type of Operation	International Charter flight			
Last point of departure	Rand Airport			
Next point of intended landing	Oranjemund in Namibia			
Location of the accident site with reference to easily defined geographical points (plus GPS readings if possible)				
To the right of the extended centre line of RWY 29 about 2 nm west of Rand Airport (S26°14,43' E028°07,05').				
Meteorological Information	Weather was fine.			
Number of people on board	1 + 9	No. of people injured	Nil	No. of people killed 1 + 9
Synopsis	<p>The aircraft took-off from Rand Airport on a commercial chartered flight to Oranjemund in Namibia. Shortly after take-off the pilot reported an engine defect and the aircraft crashed about two minutes after take-off. The pilot and his nine passengers were all killed in the accident. The post-impact fire destroyed the aircraft.</p>

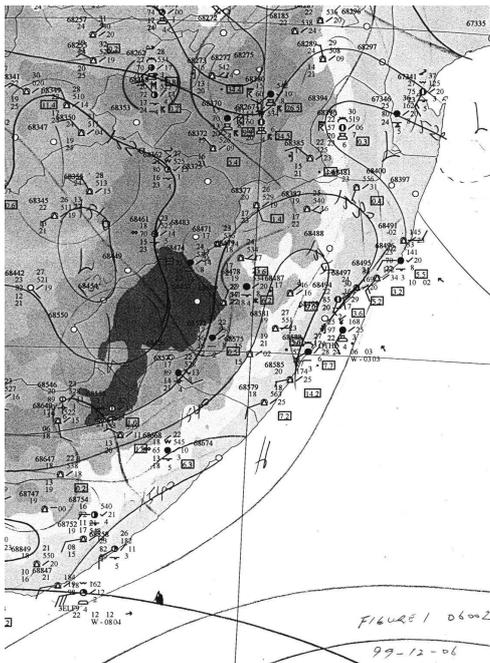
A surface trough extended from Gauteng to Maputo (in Mozambique) with warm and moist tropical air in circulation to the east of it and cooler maritime air from the south-west (figure 1). Thundershowers and showers, which occurred along this line during the night, were in the final dissipating stage at 0500 UTC (07:00 SAST).
